## **120694 – Speedometer Cable Angle Drive**

## TECHNICAL SERVICE BULLETIN

Re: Right Angled Speedometer Adaptor Failures

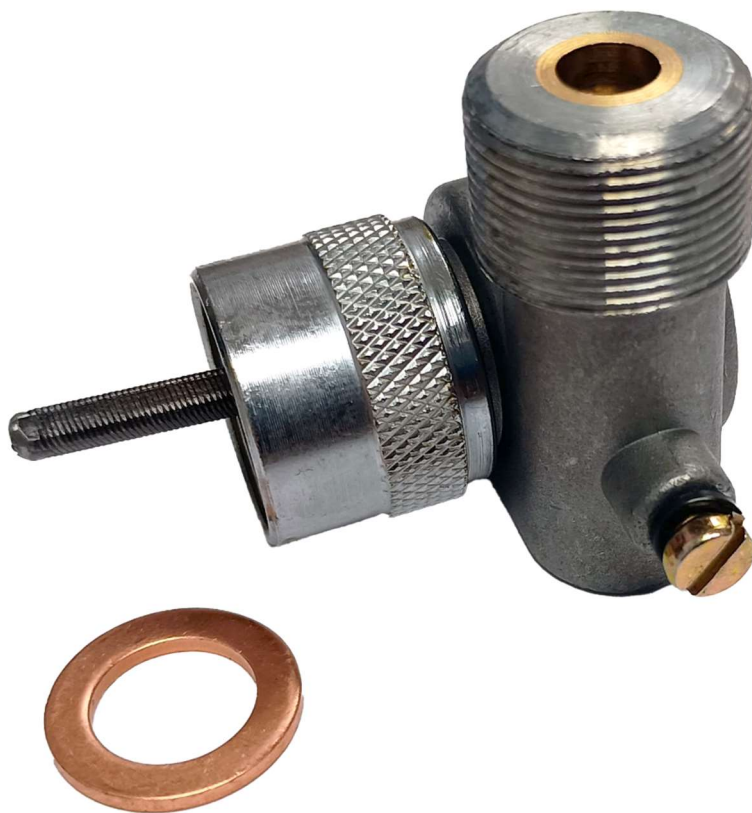
WASHER 3H 550

Repeated failures of the above have, in many instances, been caused by Washer-Adaptor to gearbox Part Number 3H 550 not being fitted when a new right angled drive adaptor is installed.

This causes an excessive end load and premature failure of the right angled drive pinion.

**IMPORTANT: When installing the angle drive, ensure a 3H550 washer is fitted as illustrated on the next page.**
