LT77 AND R380 REMOTE ISSUES

by Lorne Goldman (Edited)

LT77 AND R380 GEARBOX REMOTE ADJUSTMENT

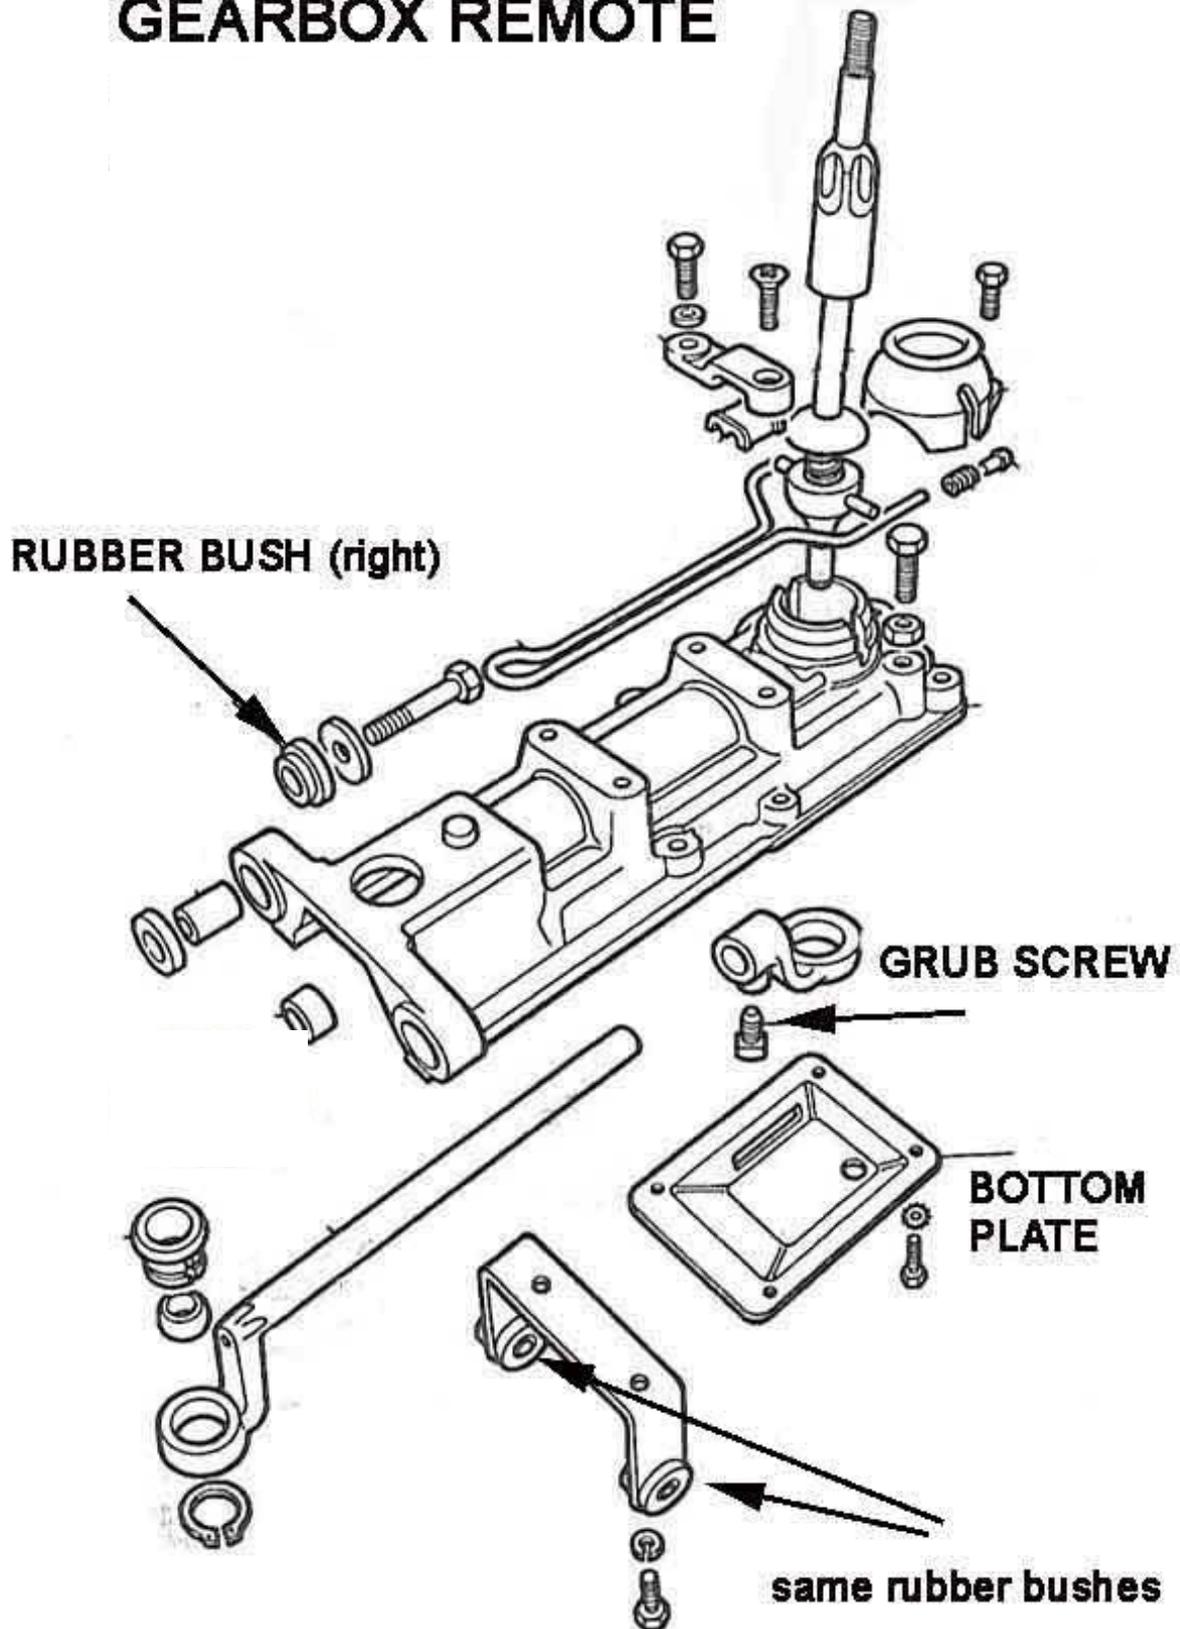
GEARBOX REMOTE

One problem is the plastic rubber bushings that interface the remote's bolts to the gearbox. Over time these rot and the remote becomes loose on its gearbox bolts. As one tries to shift, the remote moves on its bolts and has difficulty (or impossible) to move anything meaningfully or correctly in the gearbox.

The solution is to remove the gearbox/remote cover, allowing easy access to the remote and replace the rotten bushes. Ideally, get the new polyurethane ones (MGOC # UKC854P - supplied with remote).

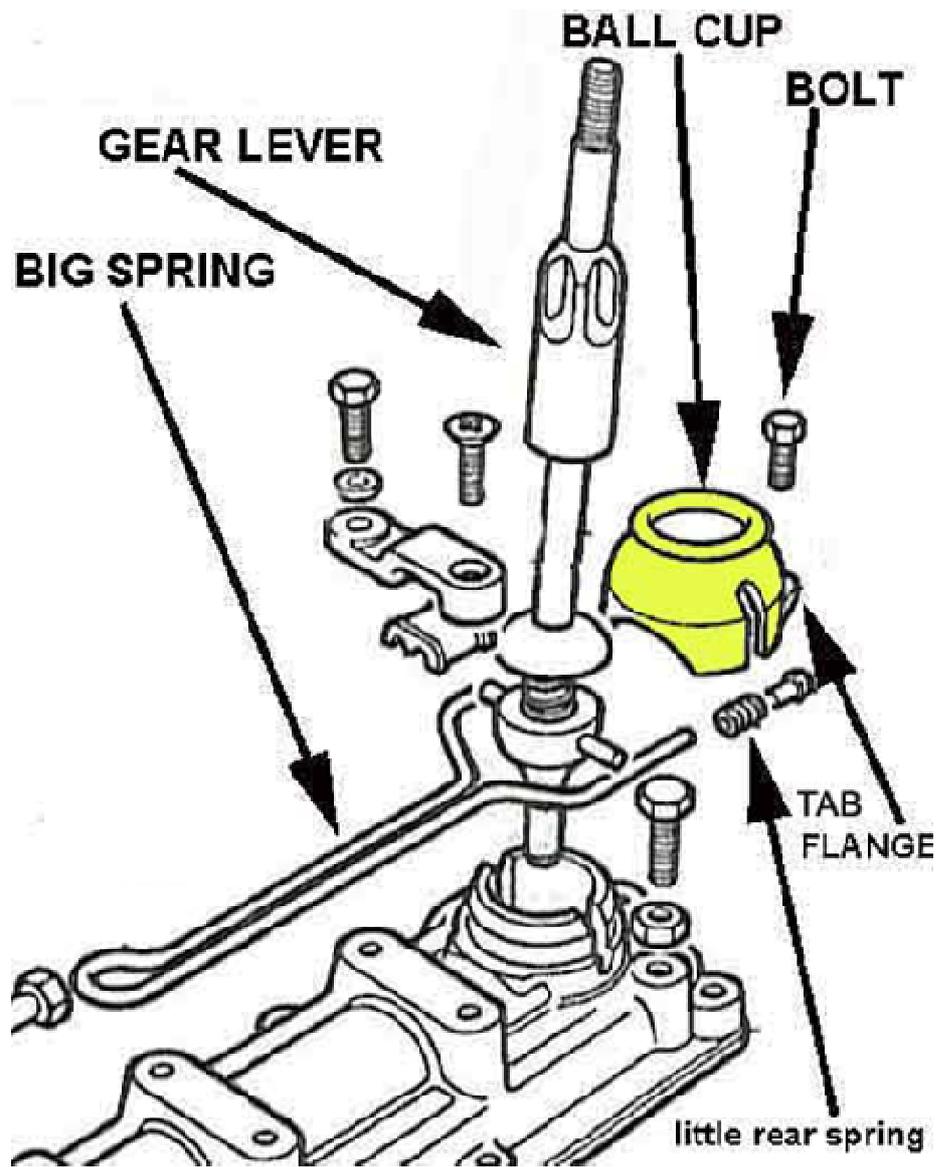
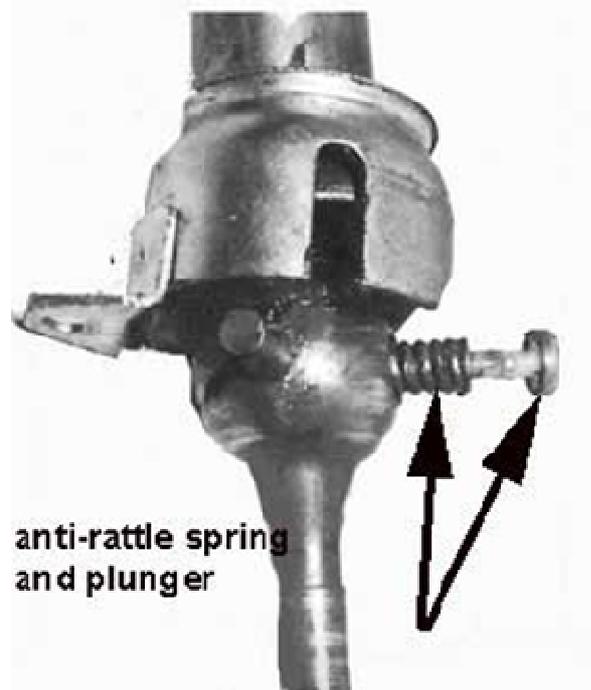
THE TENSIONING CUP (aka the Gear Lever Cap)

This is a little poorly made cup that holds the gear lever tensioned down against its springs. Part # UKC3159. It's weak point is the little tab (flange) used to secure it with a bolt to the remote body. (see the diagram) When this tab breaks, the shifter will seem loose and wobbly. To repair, one must carefully remove the lever and the cup (there is a little spring that will pop out at the rear of the ball section of the lever - don't lose it) and either spot weld it or try to find a new one.

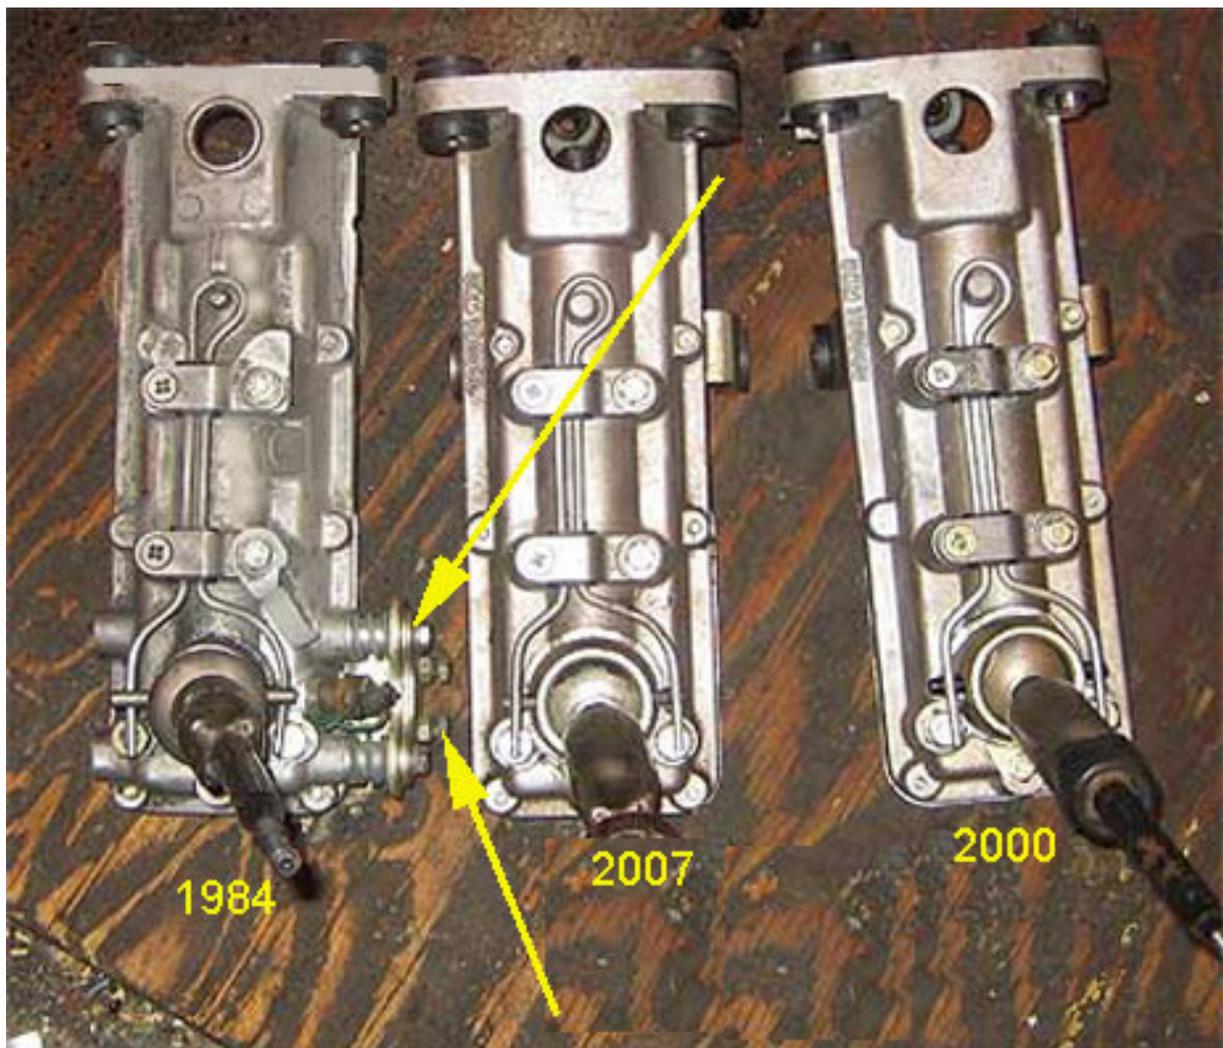
LT77 gearbox and then its replacement, the R380 used the Sd1 gearbox remote, which came in a few versions with minor differences. These remotes are pretty straight forward with only some watch points. One of these arises from the fact that the lever itself is spring-loaded. There is also a feature which prevents the lever from being accidentally placed in reverse. It is adjusted to require a "slap" movement. Over time, the springs wear, and bushes wear and a bit of a re-adjustment is called for. The first sign is that reverse becomes hard to access. Sadly, diagnosis and suggested solutions are often bad, from both amateurs and professionals. The Sd1 remote left main line production in 1987. Land Rover R380 and LT77 remotes are different. Often the clutch is suspect and I have even seen incidents where the gearbox was unnecessarily rebuilt! Friends will suggest that the lever be slapped harder (until damage occurs) or they suggest different angles to attack the lever.

1. Remove the bottom cover of the gear-lever remote assembly
2. Locate the gear lever in neutral in a vertical position.
3. Slacken the baulk plate adjusting bolts and locknuts until the baulk plate is in contact with the backing plate.
4. Tighten the adjusting bolts equally until they just start to move the baulk plate out of contact with the backing plate.
5. Adjustment should be such that an effort of 13.6 to 15.9 kgf (30 to 35 lbf) is required to overcome the resistance of baulk plate. This can be checked using a spring balance attached to the threaded end of the gear lever (gear knob end). Adjust by tightening or slackening the two adjacent bolts located on the right-hand side of the reverse baulk plate. NOTE: A minimum clearance of 0.254mm (.01inch) must exist between the upper face of the baulk plate and the lower edge of the gear-lever bush.

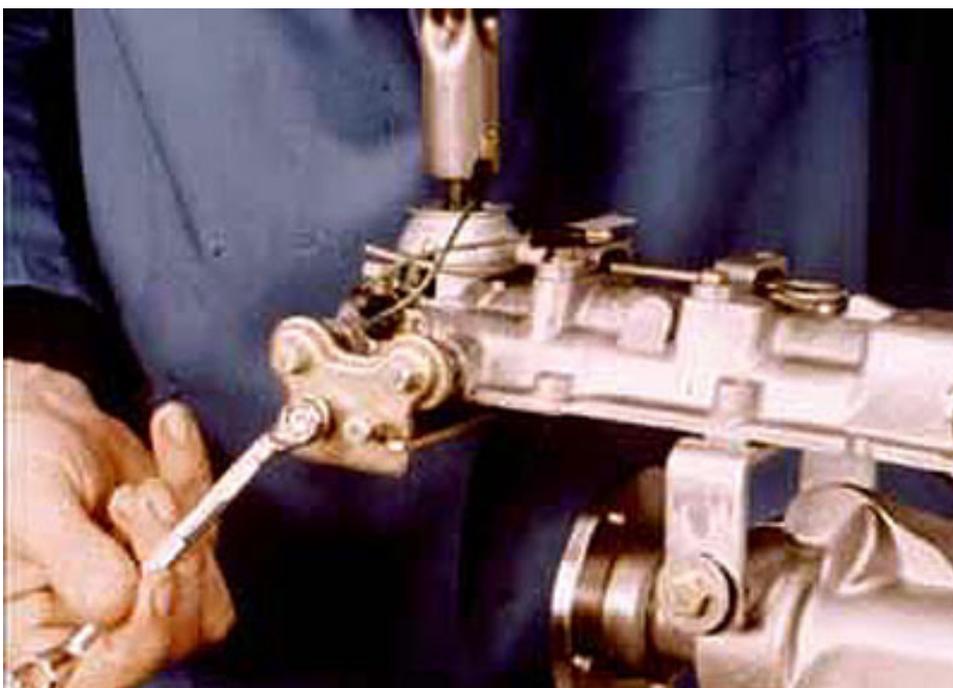
1. Select neutral and make sure the lever is in a vertical position.
2. Release the locknuts and slacken the adjusting bolts until the baulk plate just contacts the backing plate then tighten the two bolts equally until they just start to move the baulk plate.
3. Now using a spring balance, connected to the top of the gear lever, measure the force required to move the lever to the reverse gate.
4. Adjust the two bolts to achieve the correct operating load; this is (30-35 lbf) but keep in mind, when the lever is in the neutral position, a minimum gap of 0.25mm (0.01 in) must be left between the upper face of the baulk plate and the lower edge of the gear lever bush.

Next, adjustment of the 1 st/2nd gate stop. Engage 1st gear and measure the gap between the gear lever and the edge of the baulk plate. It should be 0.25-1.25 mm (0.01 -0.05 in). The gap is adjusted by fitting shims behind the baulk plate spring carriers. After making an adjustment re-check the load required to over-come the baulk plate, as reverse is selected. When all readings are correct, fit the bottom cover.

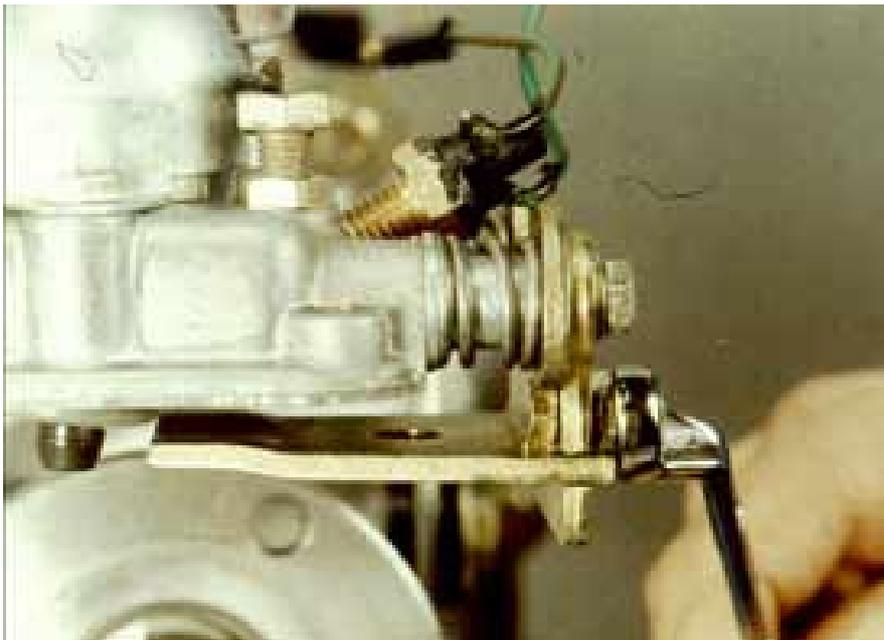
Now the gear lever bias spring, engage third gear and adjust the two bolts so that both spring legs are 0.5mm (0.02 in) clear of the cross-pin. Lightly pull the lever to the left, to take up any play, and adjust the right hand bolt downwards until the right hand spring leg contacts the cross-pin.

Repeat the procedure on the other side, holding the lever to the right; then select neutral and rock the lever across the gate.

The lever should return to the 3rd/4th gate when released. The two locknuts can then be tightened.
