## MGF and TF Hood to Door Glass Seal Replacement

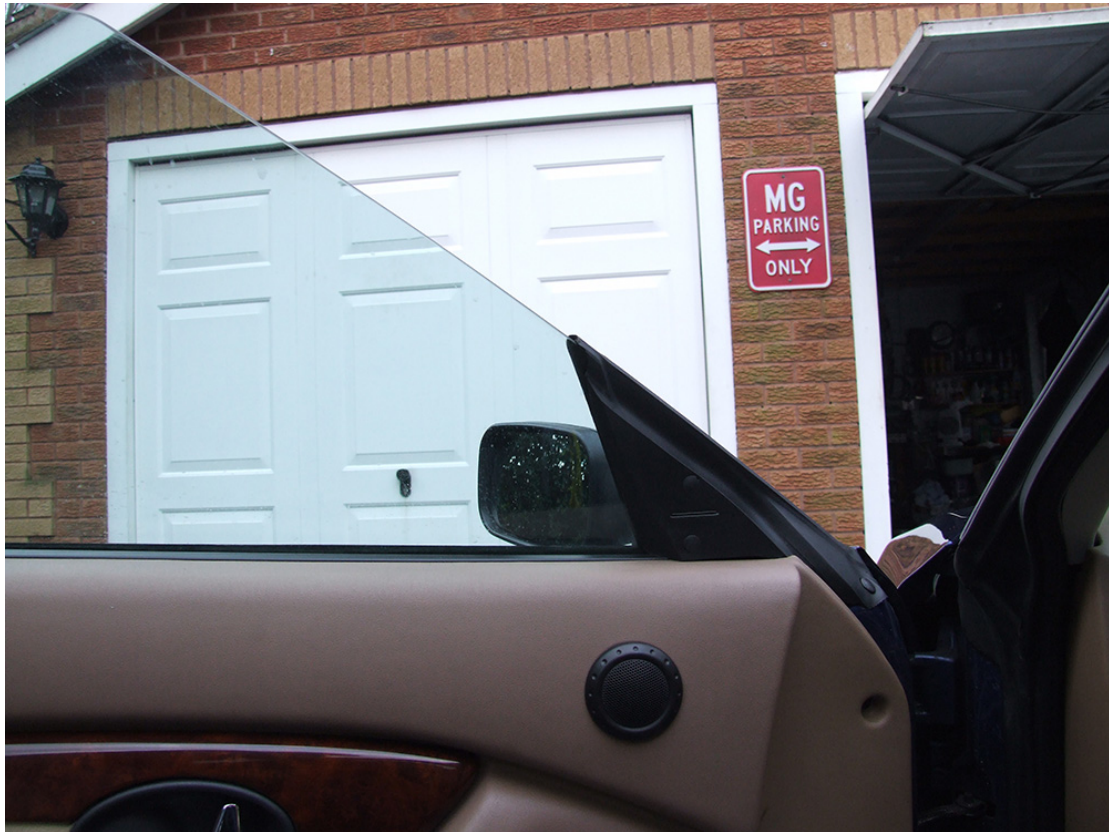
Image. 1

Image 1 shows the raised position of the door glass and note the straight edge line between the glass front edge and the 'cheater' (door mirror mounting) front edge, where they close onto the windscreen pillar. If the glass meet with the cheater creates a 'step', and usually this is a step up with the glass, then before any hood seals are renewed the correct door glass position when fully raised has to be addressed first, otherwise a new seal could be damaged in double quick time.

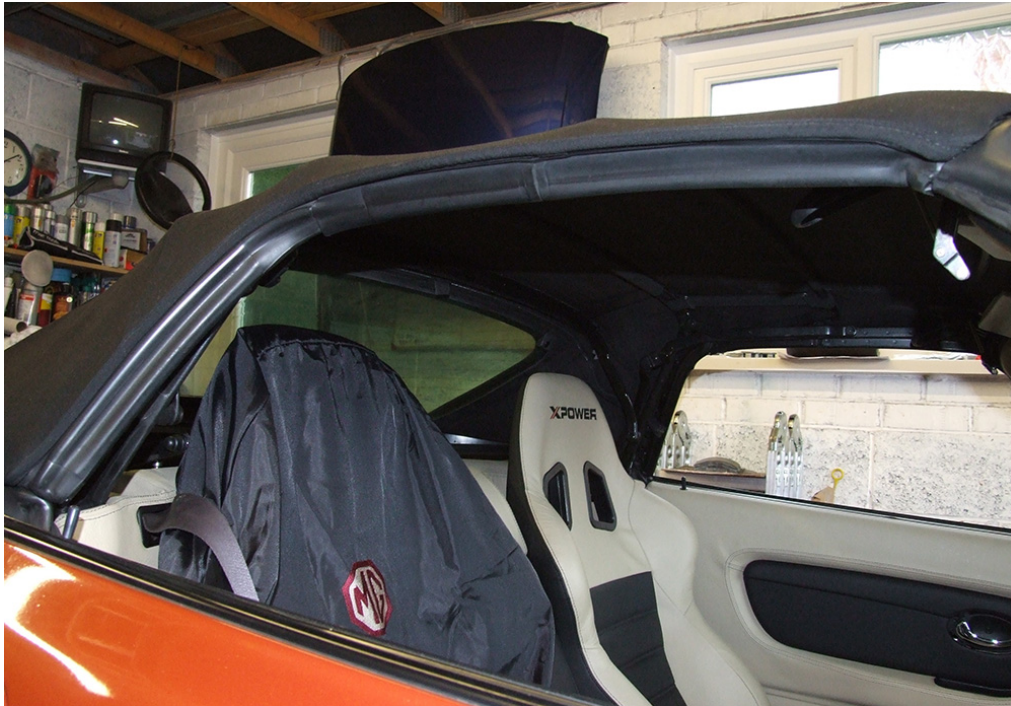
Image. 2

Image 2 shows a typically indented seal from the glass which in image 3 is on the left and shows the clear indentation that in time even with a correctly adjusted door glass will see a reduction in the weather protection.

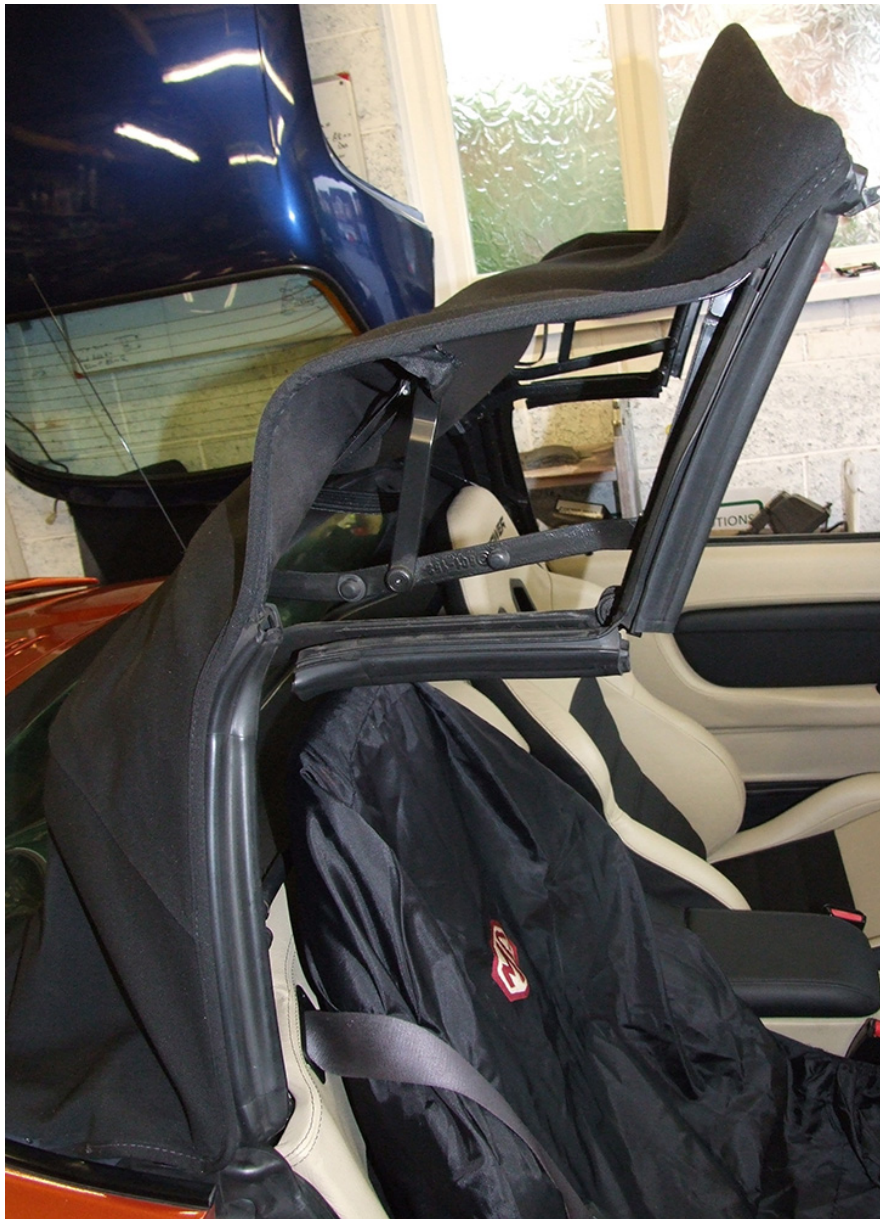
Image. 4

Removal of the old hood seals starts by releasing and partially raising the hood as seen in Image 4 and it helps to have an assistant present to hold the hood in this position whilst the following actions are followed.

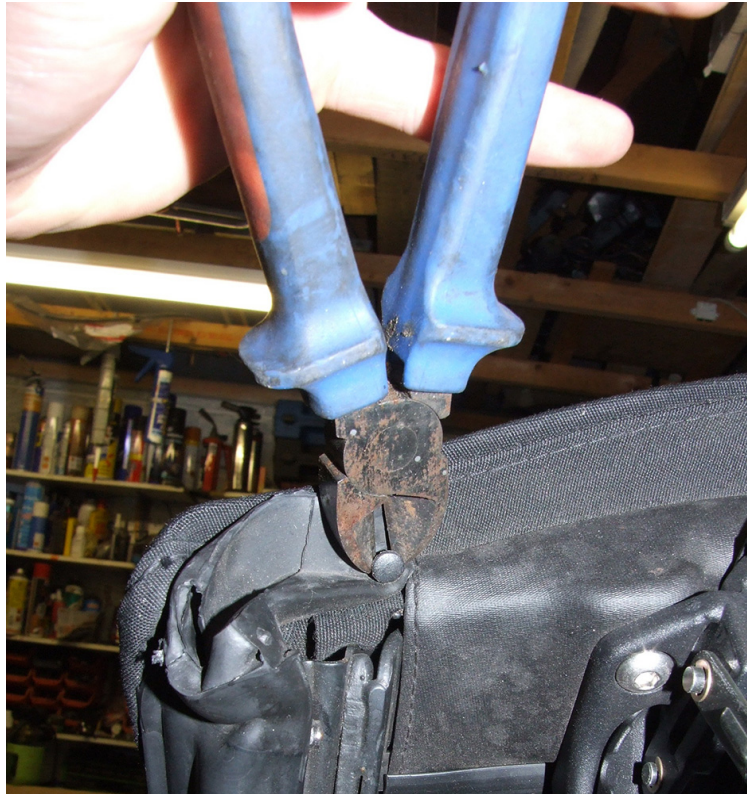
Image. 5

Firstly there is a small Scrivet (plastic rivet) holding the front edge of the seal to the hood header rail. This needs to be carefully withdrawn, ideally with a trim clip tool, but a good alternative is a pair of wire cutters as long as you do not squeeze too tight as seen in image 5. The Scrivet is just an interference fit and is to be refitted with the new seal.

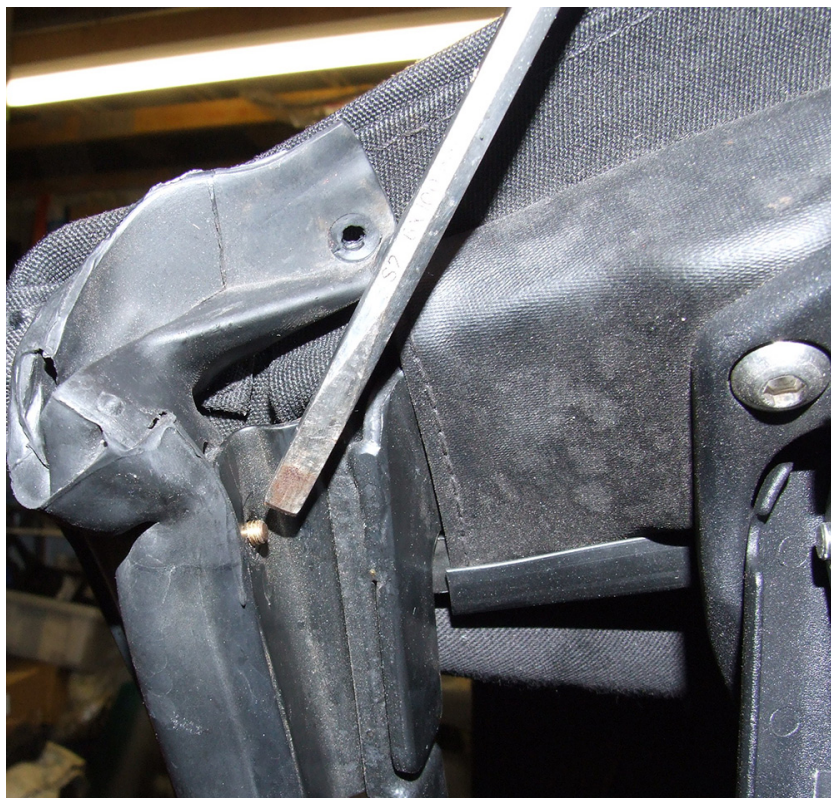
Image. 6

Next remove the nut from the stud (arrowed by the screwdriver in image 6) that is holding the seal into the front edge of the hood frame channel. Note where the ends of the seat fit in their channels and make a small mark on the channel for reference when refitting the new seal.

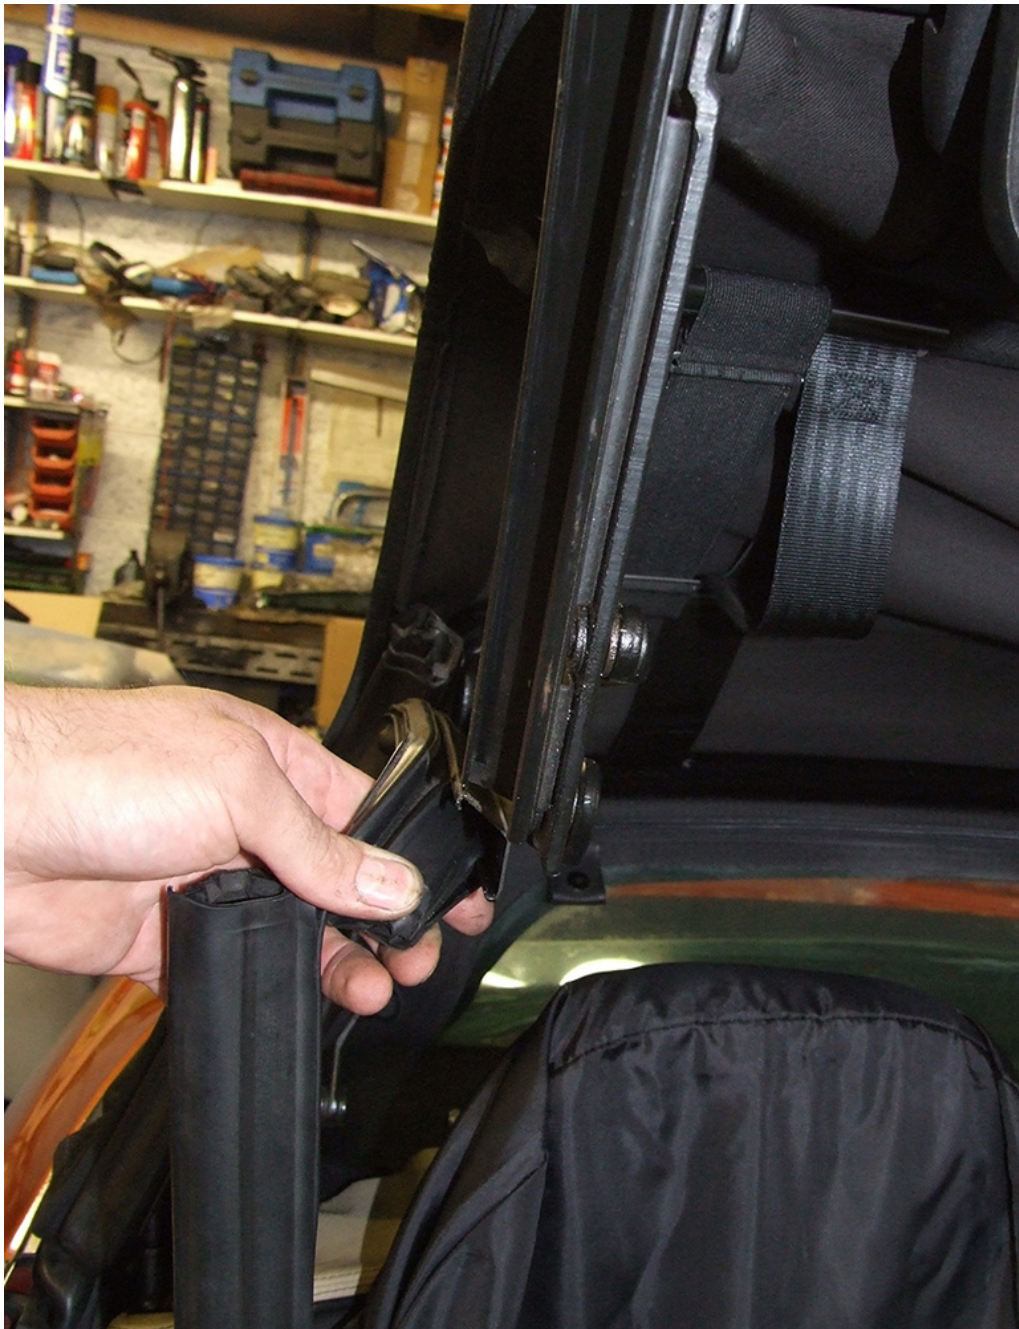
Image. 7

The front of the seal is now eased out and can be gently peeled out of the channel as seen in image 7.

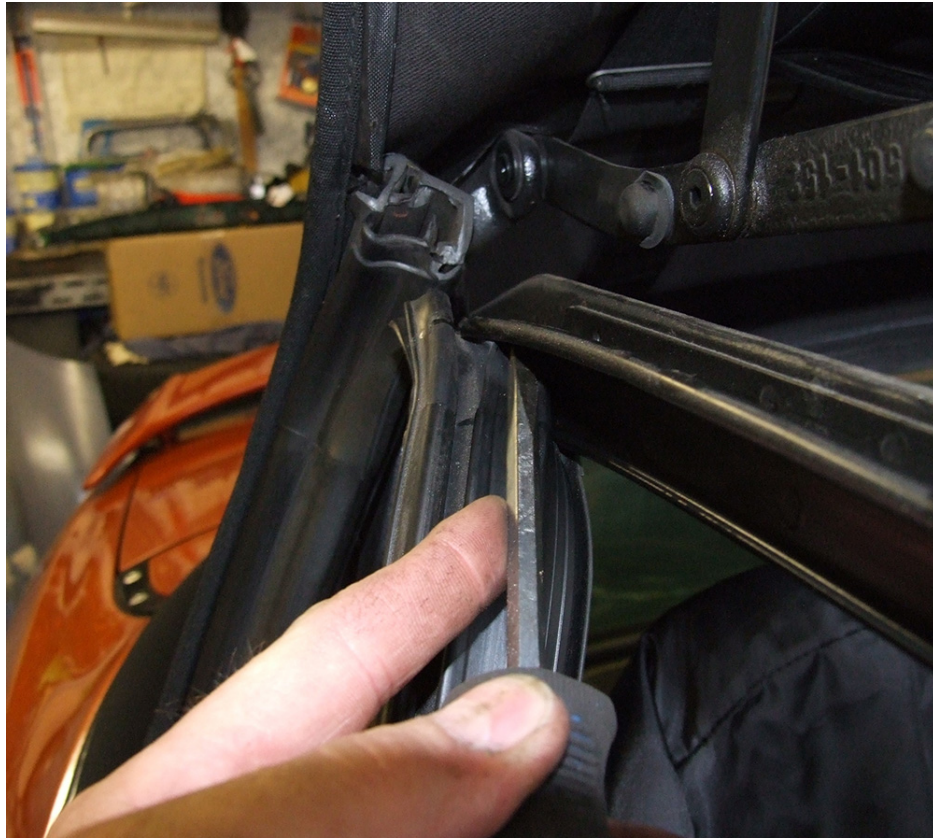
Image. 8

Note that the ends of the seal may be fixed to the channel with a small dab of glue and a little additional help with a flat blade screwdriver may be needed as seen in image 8.

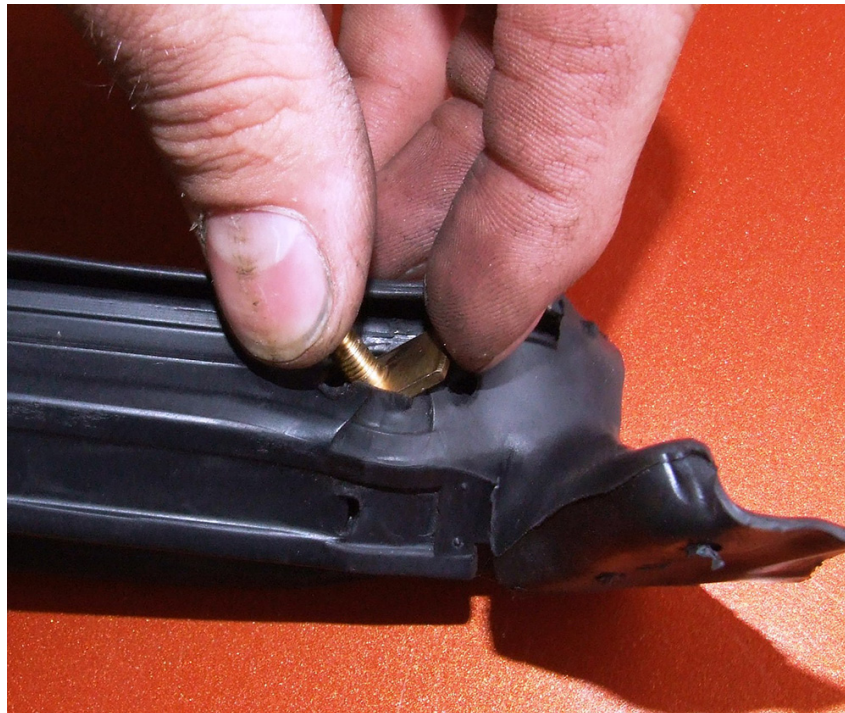
Image. 9

Now is time to remove the stud from the removed top seal and fit it into the preformed hole in the new seal as shown in image 9, noting that with a little stretching of the rubber the stud WILL fit in as can be seen in image 10.

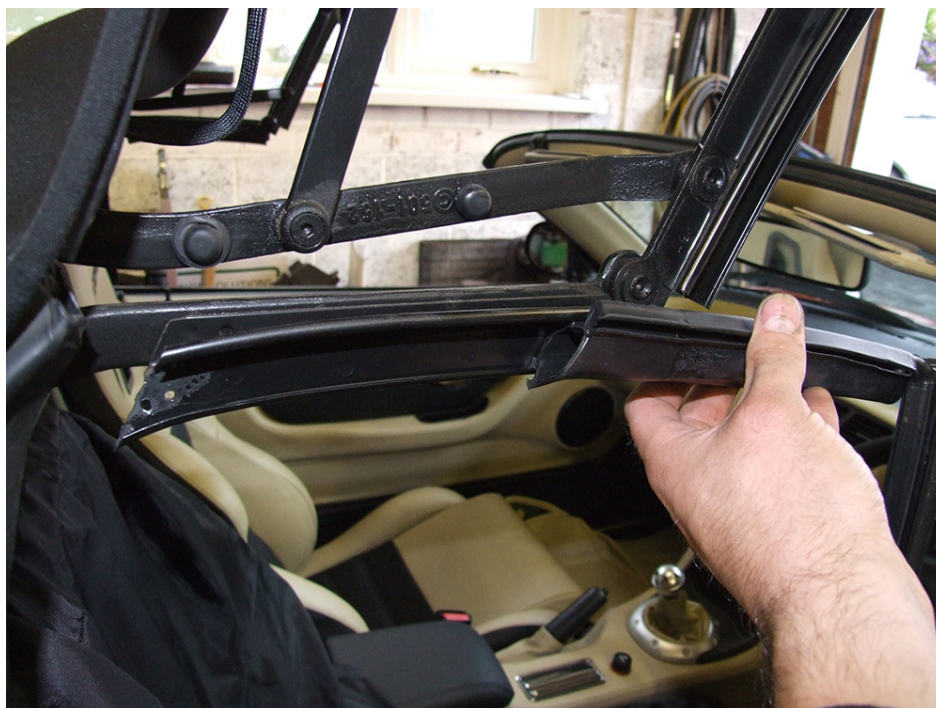
Image. 11

With a liberal coating of liquid soap on the foot of the new seal and in the channel on the hood frame it is time to slide in the front section of the seal, which should slide in and align to the position mark previously made as shown in image 11.

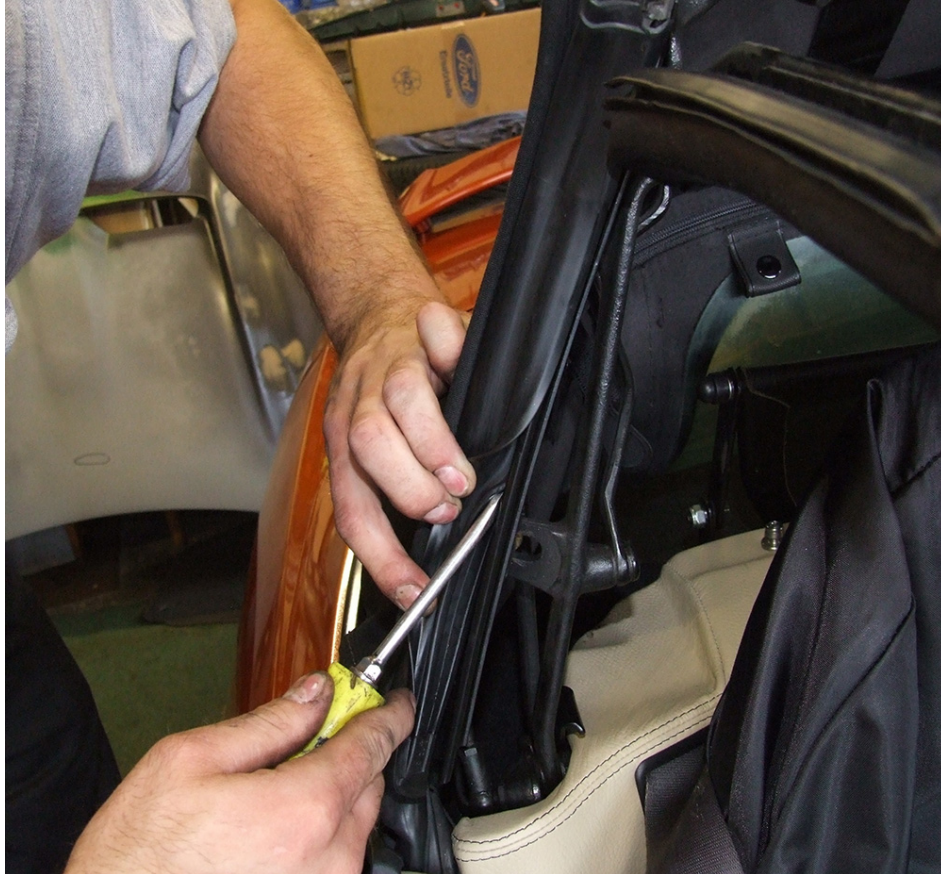
Image. 12

The separate vertical seal section now needs to be fitted and even with liquid soap to ease fitting it is expected that the seal will only slide about half way in before it binds. This then dictates the seal be manually fed into its channel by first engaging the rear (blind) side of the foot on the seal into the rear part of the channel and then with a blunt tool gradually pushing the front part of the foot into the front section of the channel as shown in image 12. This is a fiddly task but as the overall length isn't that long it is not that much of a problem.

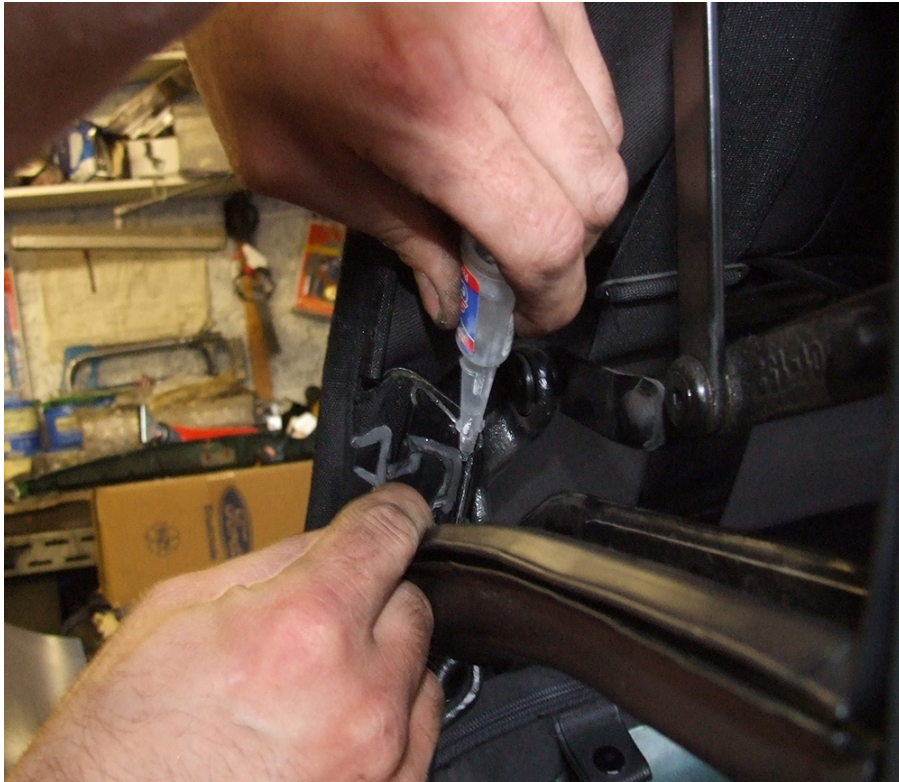
Image. 13

Check the fitted position of this seal against the previously made mark and then consider using a small dab of glue at the top of this seal as shown in image 13 to secure it against the channel and discourage movement.

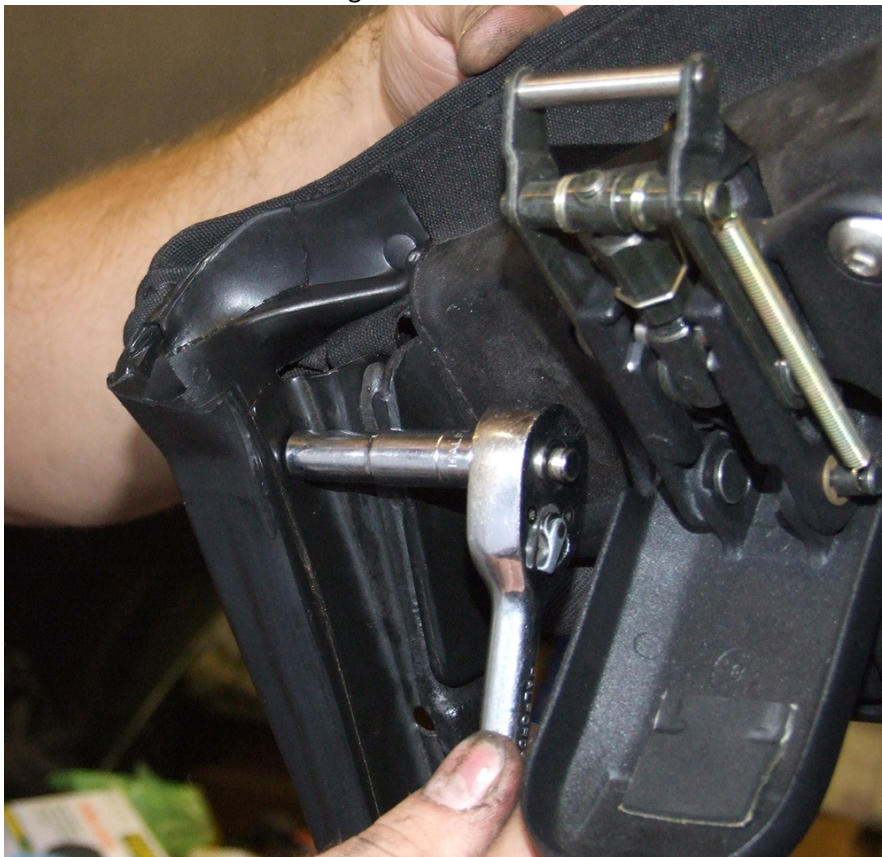
Image. 14

Finally move back to the front seal and engage the stud through its hole and refit its nylock nut as shown in image 14, and then finally refit the Scrivet that holds the front edge of the seal in the header rail as shown in image 15.

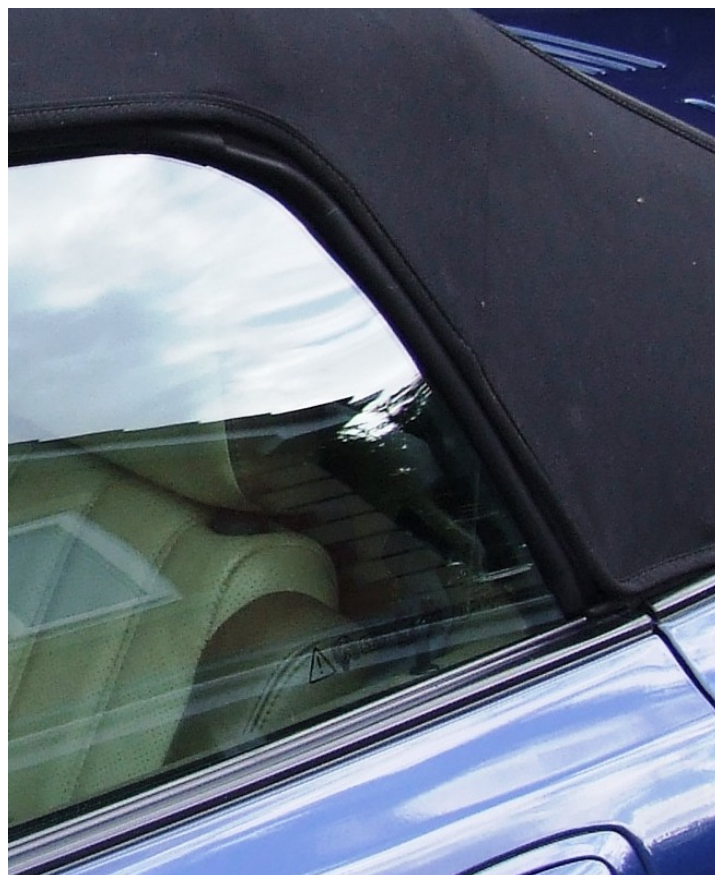
Image. 16

Finally when the door closes and the window is raised then the glass should sit with slight compression of the seal as per image 16.

Initially you may have to gently push on the glass when the door is closed, or when in the car lower and raise the window to see this compression. This may take a couple of weeks of repeated fine tweaking before settling to the correct position and during this time some treatment of the seal with a silicone lubricant helps accelerate this settlement. This small degree of owner input will help to provide a much longer service life for the new seal.
