# The MG Owners' Club

## MGF Heater Air Intake Modification

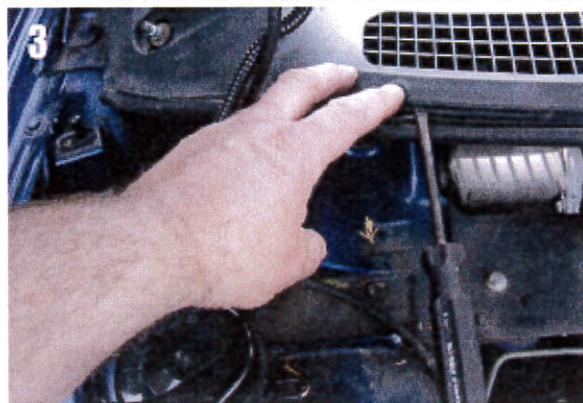
*Rear screws removed and screwdriver showing a gentle lift of one of the six front clips*

Now move to the seal at the front edge of this plastic grille and fold the top edge forwards to reveal the heads of a further six plastic trim clips. Ease the head upwards and out very gently, ideally with a trim clip removing tool, and store the clips with the other screws and caps. The seal itself is usually bonded in a couple of sections to the trim, but if not it can be placed aside for cleaning before refitting later (image 3).

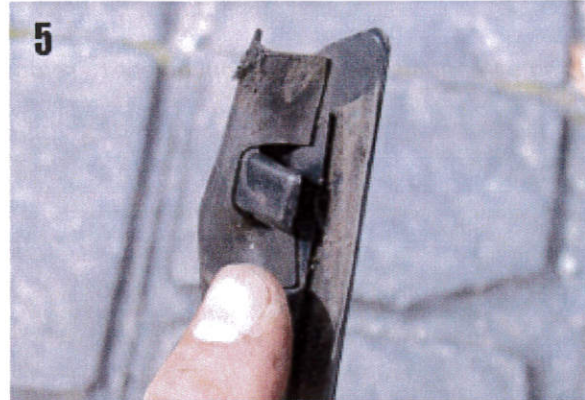
*...which is seen better from this angle*

The plastic grille is now theoretically free to lift out and here is when most people break the ends. There is a moulded tongue at each thin end of the grille that clips under the edge of the glass (image 4 & 5) and you have to take great care to fiddle the trim to disengage this. These are originally fitted before the bonnet is fitted and it is the hinges that restrict the simple removal of this trim, although with care this is possible.

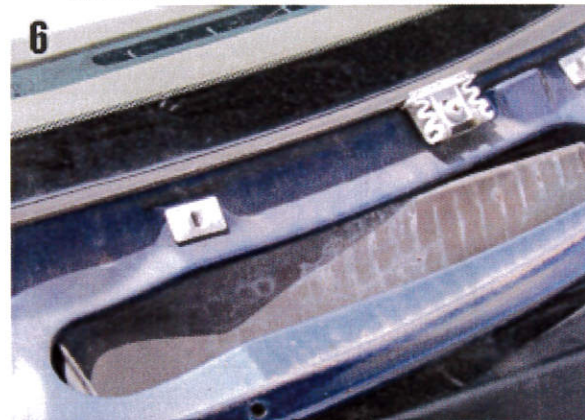
and for those wondering what the purpose of the spring clip is, it is to stop the plate vibrating. As an aside, I found that by simply spraying a light application of aerosol spray grease through the plastic grille helped delay the onset of serious corrosion.

*Air intake aperture showing rain deflector that has not rusted as badly as many due to occasional spraying as mentioned in text*

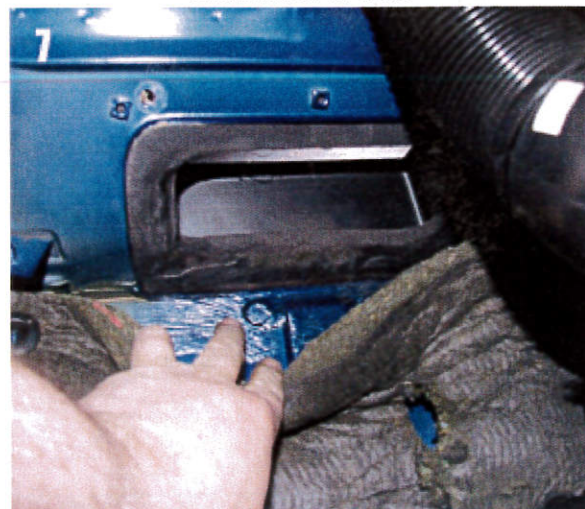
*Exposed underside of the air intake - looking from the footwell and showing one of the two fixing that have to be removed*

Removal of the chamber is next, starting inside the passenger foot well. Firstly remove the glove box for better access behind and then remove the heater air duct that connects the underside of the soon to be removed chamber to the heater unit (image 7). This is a simple removal of a single M10 nut and easing the duct off, just as was described recently in the heater resistor replacement feature in the April 2008 issue. Interestingly there was no nut fitted to my car and with no signs of compression on the plastic it seems that there never was one. Once removed the compressed seal at the base of the chamber can be seen along with the two rear 10mm headed self-tapping bolts that hold the chamber to the car were removed.

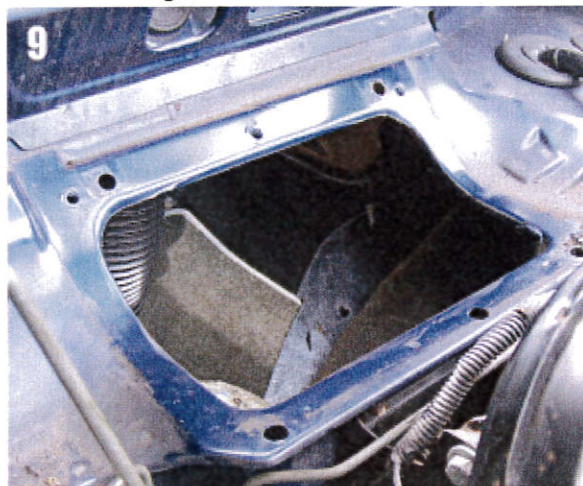
*Original air chamber removed showing how dirt collects*

The shape of the chamber prevented simple removal but it was clear that if the chamber was cut it could then be compressed, rotated and lifted out. Having an air saw saved much effort as the plastic used for the chamber is quite thick, and once cut to allow the front upper half to be folded open, allowing the whole chamber to be rotated upwards, clear of the servo and out. The space revealed was surprisingly large (images 9 & 10).

Years of inaccessibility means there is plenty of dirt and here is a golden opportunity to have a good clean before the new duct was fitted. There was also some excess seam sealer causing lumps where the seal fits, so these were trimmed flush to aid the life and efficiency of the new seal.

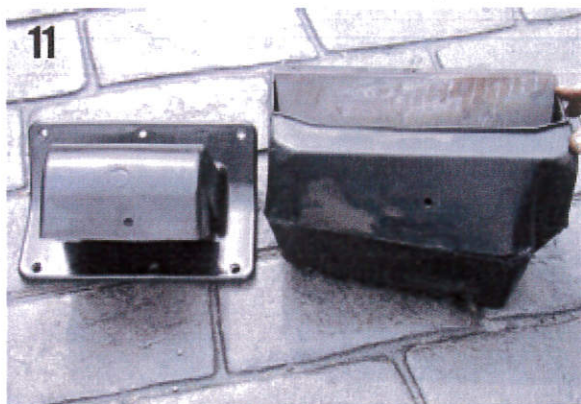
Whilst my car was not suffering water ingress and had a bearably presentable rain deflector, there was still the desire to improve things. This was mainly driven by the simple fact, probably little known, that from mid 2003 (VIN 3D612109) the TF benefited from a completely new air intake moulding that was smaller, neater, better secured and adopted an almost stupidly simple shape to prevent rain entry. The image of the two types illustrates this perfectly (image11).

*New and old air chambers*

Fitting the new TF air intake funnel is by comparison to the removal of the original chamber, a doddle. There are some differences beyond the obvious visual ones and the most important one is the use of six fixings instead of four, so the clamping load is better spread, but four of these six fixing holes are in different positions. Immediate thoughts of drilling new holes were unfounded on this 2001 car as the required holes were already present, including three captive nuts and this may also be the case for earlier cars too.

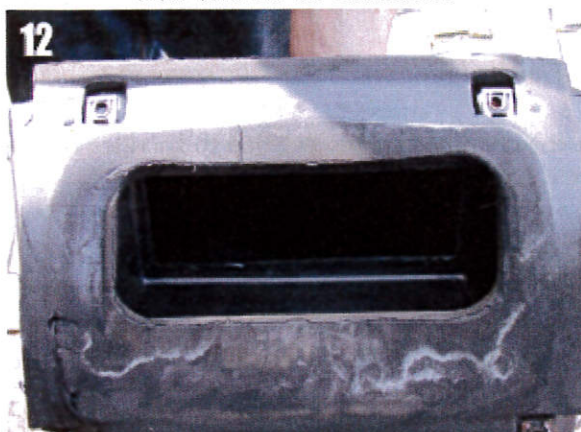
Early MGFs were more prone to leakage in this area and this was due to a weakness in the seal design that's glued to the base of the plastic chamber. The seals were uprated from around 1998 and whilst this significantly reduced the problem it did not always provide a complete solution. The image showing the seal on the base of the chamber removed from my 2001 car shows clear water staining and indicates that whilst the car was dry, water was still able to penetrate and in time this would have become a problem. Incidentally the damage seen to the lower left of the seal was done removing the chamber.

*Underside of original chamber showing water staining on seal indicating leakage was not far off*

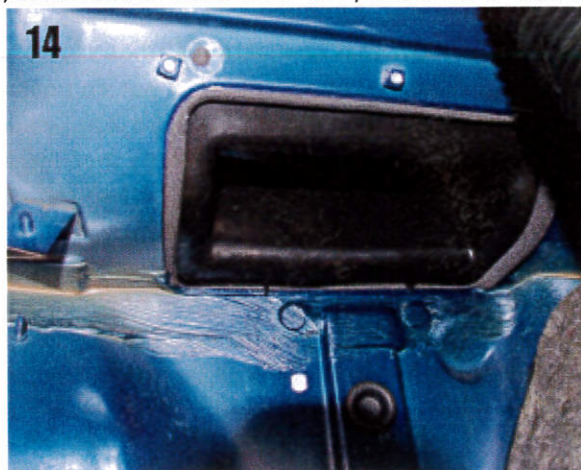
*Underside of new duct in fitted position*

The end result (images 13 and 14 ) is in my mind neater and simply a better design and the wonder is that it was not fitted earlier. In testing I did note that there seemed a little more air noise when the fan was on full power, but that was from outside, inside was no noisier.

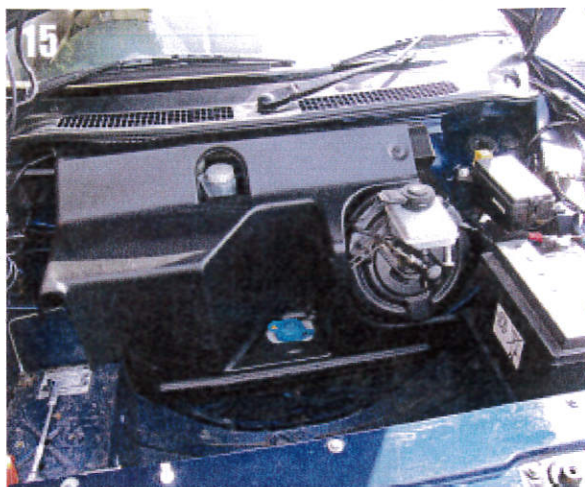
*Finished with original plastic cover in position*

Time now to refit the trim and wipers and here I simply make the point to take the same care with refitting the plastic grille as was needed when removing it. Also do not screw in the rear fixing screws too tight, as this will break the plastic clips. It is also an idea to dribble some water around the new intake in a manner that imitates rain draining off the screen and down around the intake, to check for any leaks. When satisfied the interior parts are refitted.
