MGF Bonnet Release Cable Replacement

Installation Advisory

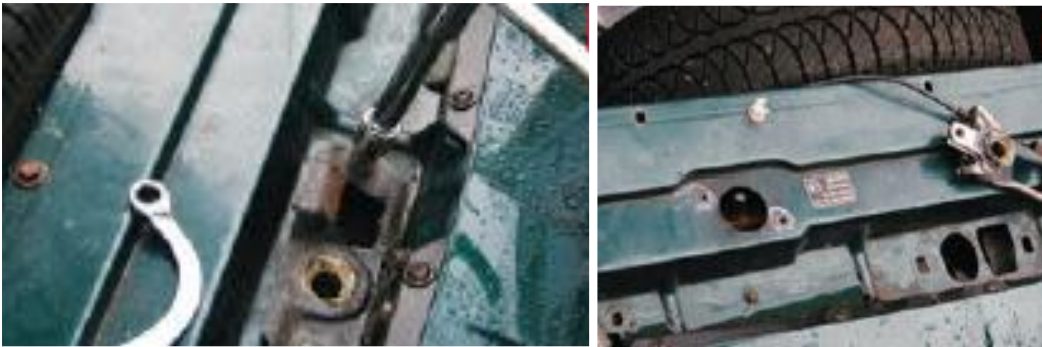
Undo the bolts that hold the slam panel and then prise the latch assembly out between the slam panel and the boxed in radiator. Undo all the bolts that locate the slam panel and the bolts that hold the radiator top locating plates with their rubber inserts. Once it's been released the radiator can be gently pulled back and the cable and the latch assembly pulled through the gap between the top of the radiator and the panel. It may be possible to accomplish this task from below the car.

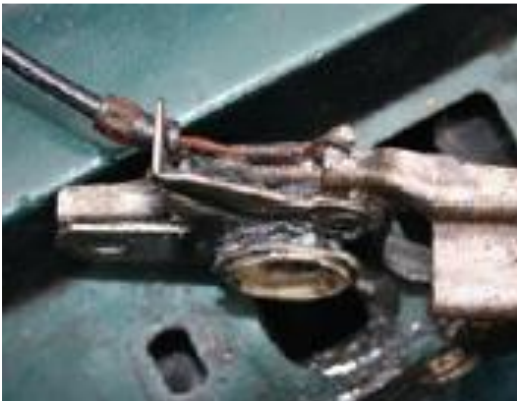
Once the latch is exposed the front end of the cable can be unclipped with the help of a pair of pliers. If the latch assembly is looking corroded and partly seized now is a good opportunity to give it a thorough wire brushing and lubricate all the moving parts liberally.

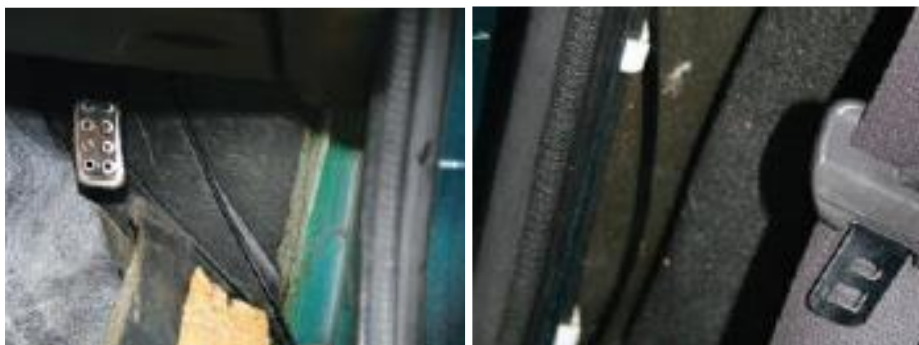
With the end disconnected it is now a case of withdrawing the cable through the bodywork of the MGF. The cable is routed through the driver's footwell and then along the side of the cockpit, up the rear of the door aperture and then through into the boot. There are various rubber grommets that ensure the cable is located and does not chafe against any sharp edges of the bodywork and these will have to be prised out as the cable is withdrawn. The replacement comes with all the new grommets required to fit it into place.

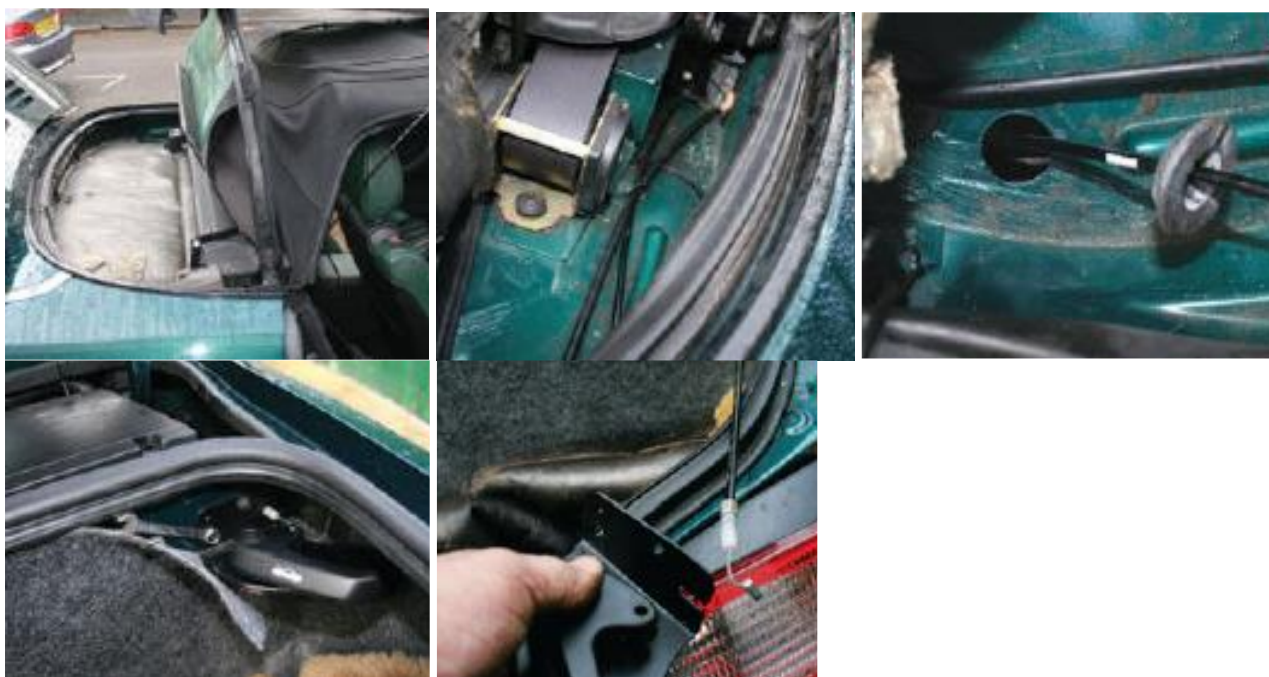
Lifting the carpet clear of the side of the cockpit reveals the cable route and the run of clips that are fitted to ensure it follows a set path, which it shares with the throttle cable and is clipped alongside. As you withdraw the cable make note of the path it takes and the clips that hold it down.

The cable unclips from its guides behind the driver's door. Unclip the rear of the soft top and take out the carpet and sound deadening material. The cable can then be clearly seen and subsequently pulled through its rubber grommet back into the top of the engine compartment. Detach it from the pull handle by unbolting the two 8mm locating nuts. The cable can now be removed.

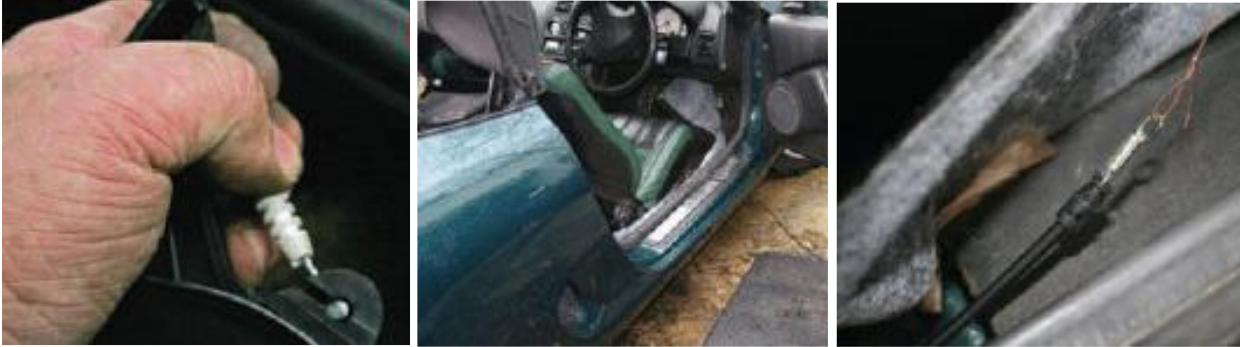
Start by working backwards, taking time and care to locate and refit the grommets. There are round holes at either end as you feed the cable through. It tends to droop under its own weight and will not pass cleanly through the hole on the opposite end. To overcome this, take a length of thin wire and feed that through from the other end, twisted it around the loop of the new release cable and then pulled it all through the box section.

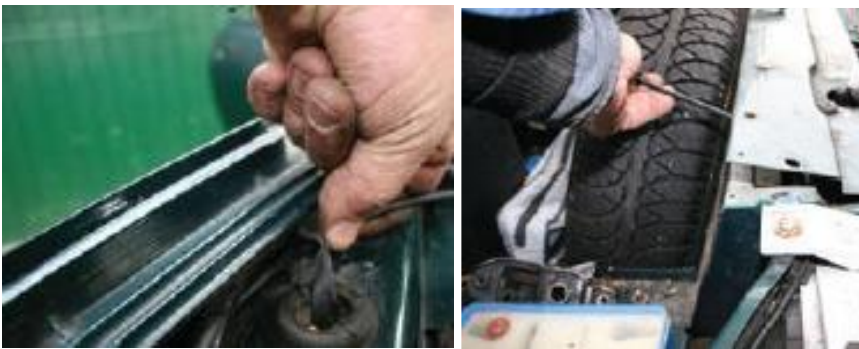
Feed the cable across the footwell and up, through into front bonnet area via a hole at the top of the footwell. Once the cable is through the grommet, it has to be pushed back into place. Clip the cable into place inside the front boot and fed through the last hole into the space beneath the slam panel.

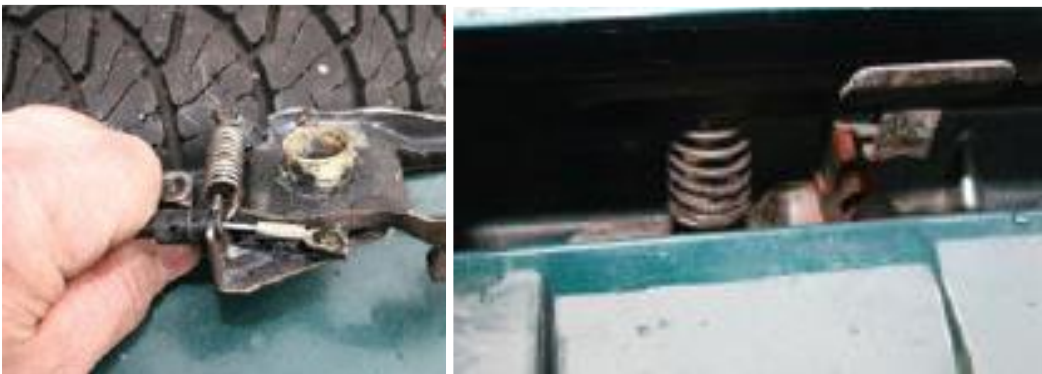
Clip the end of the new cable onto the latch assembly and push back into the space beneath the slam panel. The latch has captive nuts and it is quite easy to re-attach it to the slam panel. Before tightening the latch bolts it will be necessary to lower the bonnet and align the latch with the locking pin. Once they meet successfully the bolts can be fully tightened. Before shutting the bonnet have an assistant operate the lever to ensure it operates the latch effectively.

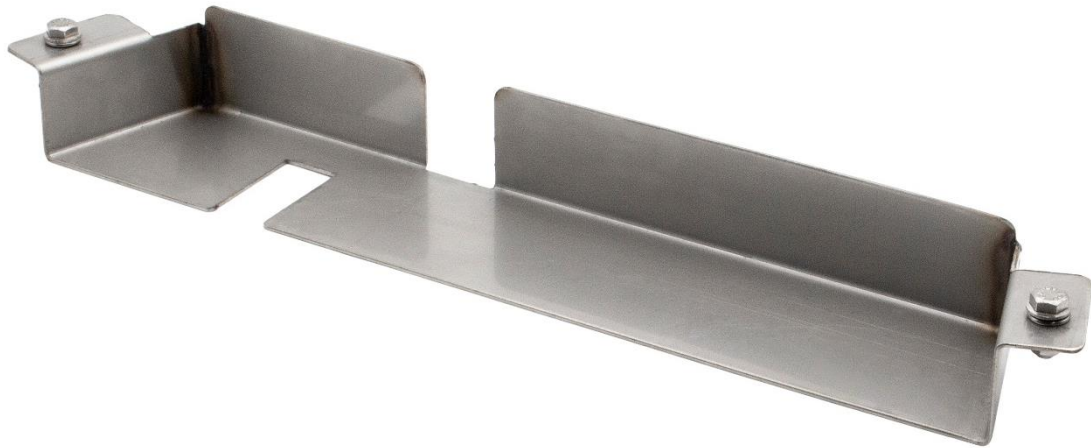
MGF/TF Bonnet Latch Shield – K785

Located on the underside of the slam panel, the bonnet latch shield on MGFs & TFs is designed to protect the bonnet latch and striker assembly from road grime leading to corrosion which can make for difficulty in opening the bonnet and additionally serves to prevent thieves from making unauthorised access to the car. Manufactured in the UK from stainless steel, the cover is pressed and tig welded, supplied complete with stainless steel fixings.
