Two Speed Heater Motor Upgrade F217

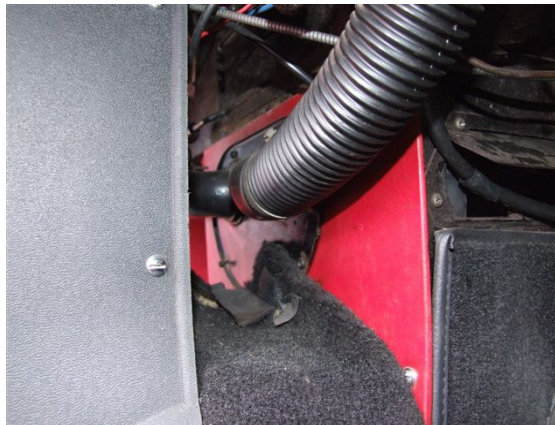
6. If the heater box requires complete removal for restoration you should now disconnect the air control cable from the rear of the air control knob located on the dashboard.
7. For early MGBs (62-70) the steel plate holding the two 90 degree rubber demister elbows will require removal with a Phillips screw driver. To access these screws remove the fittings securing the radio fascia to the centre console frame and gently pull towards you, taking care not to inadvertently disconnect the speaker or ancillary wiring. Once the steel plate is free you will then be able to remove and set to one side the two push fit hard plastic pipes which locate into the air control box.

Early MGB Demister Arrangement (62-70)

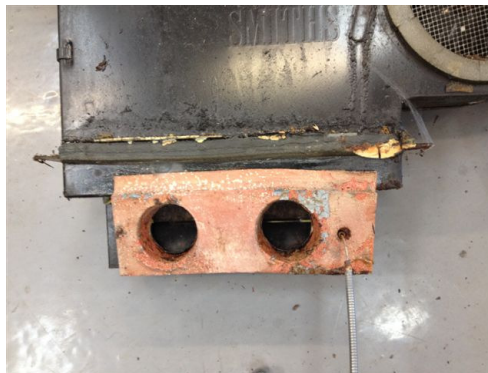
9. To fully remove or partially lift the heater box above the bulkhead of the car we recommend roping in a volunteer to feed the air control cable through the bulkhead as the heater box is lifted up. The job is made easier if the bonnet is propped up by using a long stick to afford better access. On later cars where the rubber seal is present you may find the seal has gone hard making removal more difficult. If this is the case, unscrew the foot-well vents and use a long screw driver to prise off the seal from the air control box.

Original seal on later MGBs (70-80)

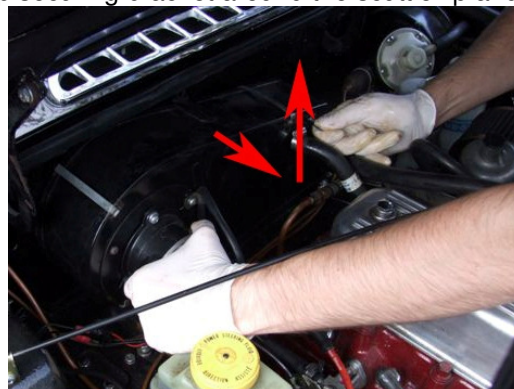
10. If the heater box is in good condition you can now prise off the retaining clips that hold the front of the heater box to the case and set the front cover to one side. If complete restoration of the box is desired then continue to lift until free of the bulkhead, taking care to guide the top securing bracket around the scuttle lip and out of the car.

Lifting the heater box

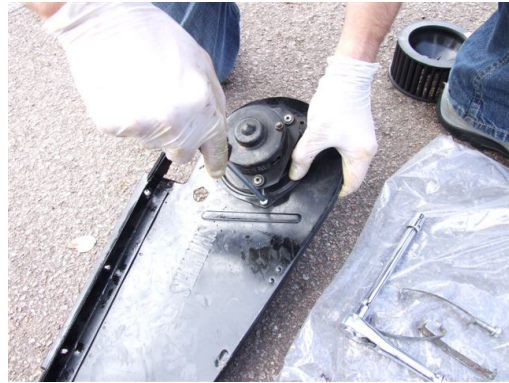
Strip down original system

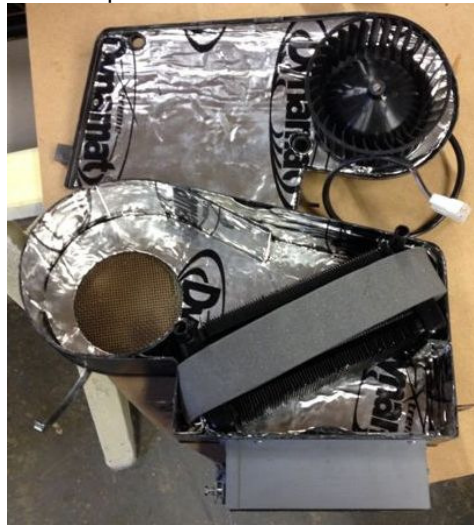
16. If you have restored and re-painted your heater box we recommend you allow it to fully harden before commencing re-assembly.
17. To minimise thermal loss and ensure complete isolation we recommend that Dynamat Extreme is applied on the inside and rear bulkhead side of the heater box and Dynaliner

applied on both sides of the air control flap. Using Dynamat provides a considerable advantage over the standard specified seals which have a much shorter lifespan.

Using Dynamat & Dynaliner

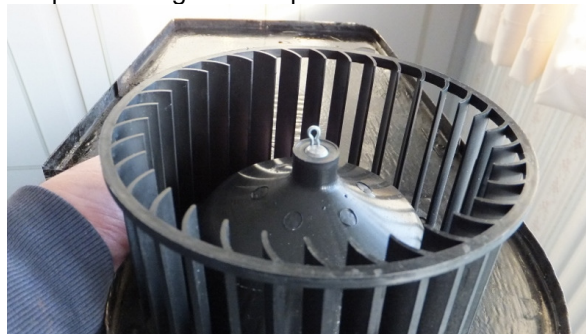
18. Refer to step 14 to mount the motor. As originally specified a P clip should be used on the motor plate to retain the heater motor harness. Slide the impellor over the motor spindle and lock into place using the R clip

Fitting the Locking R Clip

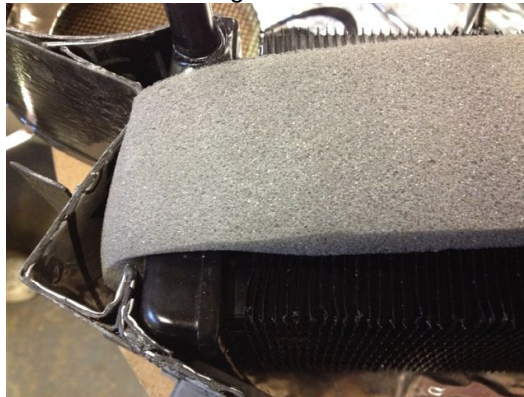
24. Carefully slide a new heater matrix foam into place and then fit the heater matrix into the casing replacing the rubber inlet/outlet grommets on the front.

Matrix with new foam seal
