Part Number : G359 Suitable for : MGF / TF

Supplement Fitting Instructions For Vehicles Fitted With Steptronic Gearboxes.

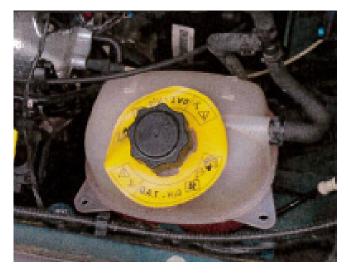
4.

Clip the sensor to the bottom of the new expansion tank and fit the two supplied metal tubes into the plastic tank pipes as this will help to prevent the pipes from crushing when tightening the hose clips. Then refit tank in reverse order. Then top up with fluid from the old tank. You may find in necessary to top up with new anti-freeze/ water mixture.

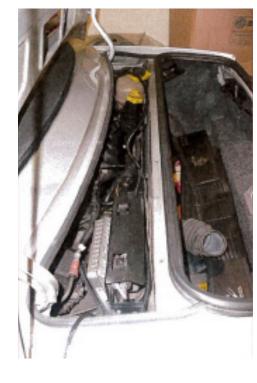
9.

Route long part of harness through grommet on left hand side just above car main harness grommet. You will need to make a hole in original grommet.

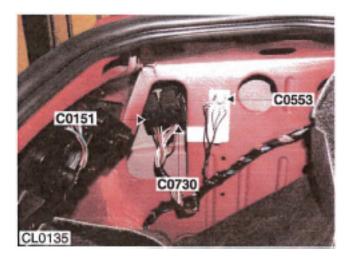
The live connection (green with yellow trace wire) needs to be spliced to a 12 volt ignition feed. On vehicles up to chassis number 610317 this can be done by connecting to the white wire going into the relay pack situated behind the engine management ECU mounting plate. On vehicles from 610318, the white wire on the fuel pump relay is situated in the boot, behind the boot liner on the LH side. There are two relays here and the one required is mounted furthest back. (see picture) Once the green and yellow wire is spliced to the white wire, insulate the connection.
