Two Speed Heater Motor Upgrade F217

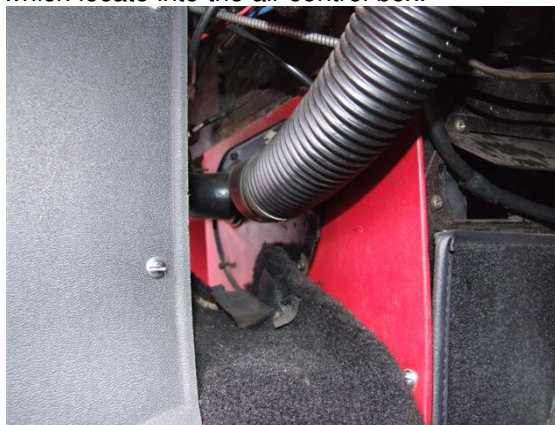
6. If the heater box requires complete removal for restoration you should now disconnect the air control cable from the rear of the air control knob located on the dashboard.
7. For early MGBs (62-70) the steel plate holding the two 90 degree rubber demister elbows will require removal with a Phillips screw driver. To access these screws remove the fittings securing the radio fascia to the centre console frame and gently pull towards you, taking care not to inadvertently disconnect the speaker or ancillary wiring. Once the steel plate is free you will then be able to remove and set to one side the two push fit hard plastic pipes which locate into the air control box.

Early MGB Demister Arrangement (62-70)
